AUGUST 1968 THE NAVAL AVIATION SAFETY REVIEW

# HARD LANDINGS

**A review  
of FY 69  
major hard landing  
accidents indicates  
that lack of  
effective supervision  
was a major  
factor.**

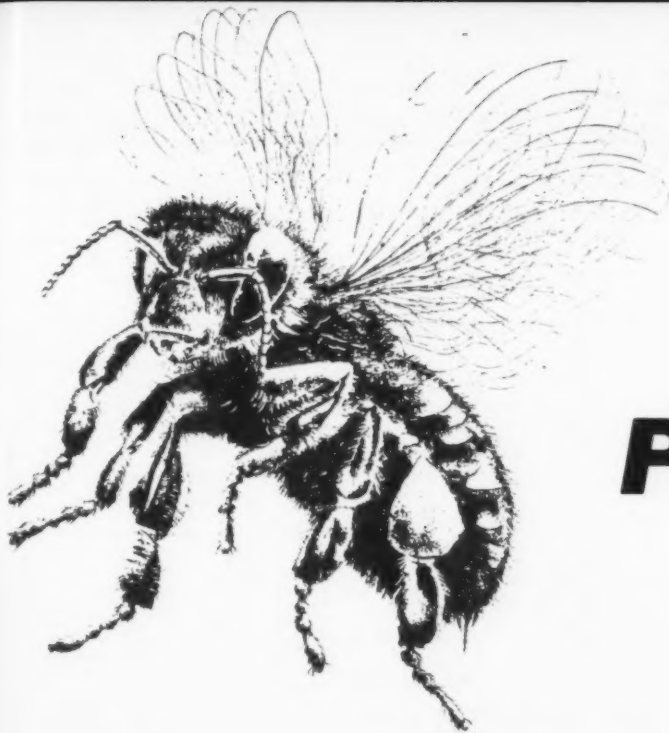
In this case the investigation determined that the erratic airspeed indication was caused by insects nesting in the pitot tube. This particular aircraft was based in the Caribbean area and the insect involved was identified as a leafcutting bee. The identification of the insect may not be as important to flight safety, however, as the recognition that there are a number of types of insects which can (and do) enter the aircraft pitot-static system and cause subsequent malfunctions of one or more flight instruments.

The problem of insects blocking pitot-static systems is one which occurs most frequently in the Caribbean and other tropical areas. In most cases squadrons and stations based in the area are alert to this hazard and take all possible precautions to ensure against it. On the other hand, squadrons which deploy to these areas from the North may not be aware of this potential hazard. This is illustrated by the experience of a P-3A squadron whose aircraft deployed to the area for a short period. Two incidents of blocked pitot-tubes were experienced during the first four days of operation. In one of these incidents both the pilot's and the copilot's airspeed indicators failed to indicate during the takeoff roll. The takeoff was successfully aborted. In both cases the investigators determined that pitot tube covers were in regular use when the aircraft were on the ground, suggesting that insects may have entered the pitot tube

opening via the openings in a loose fitting pitot tube cover. This indicates that it is not sufficient to merely install the covers; they must be installed in such a manner that the entry of insects is positively precluded.

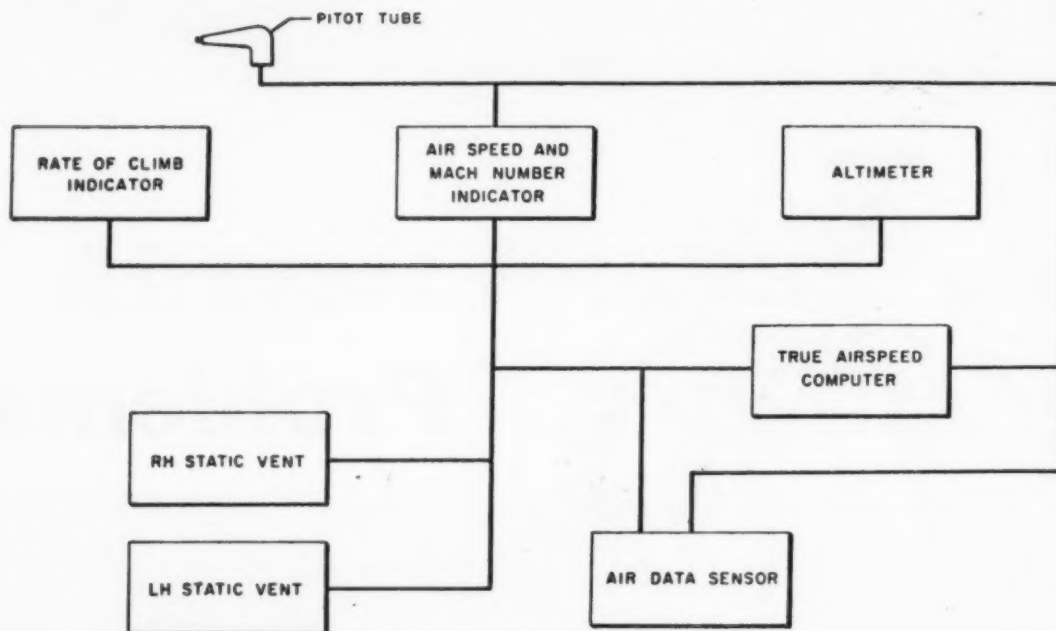
Block diagram of typical pitot-static system.

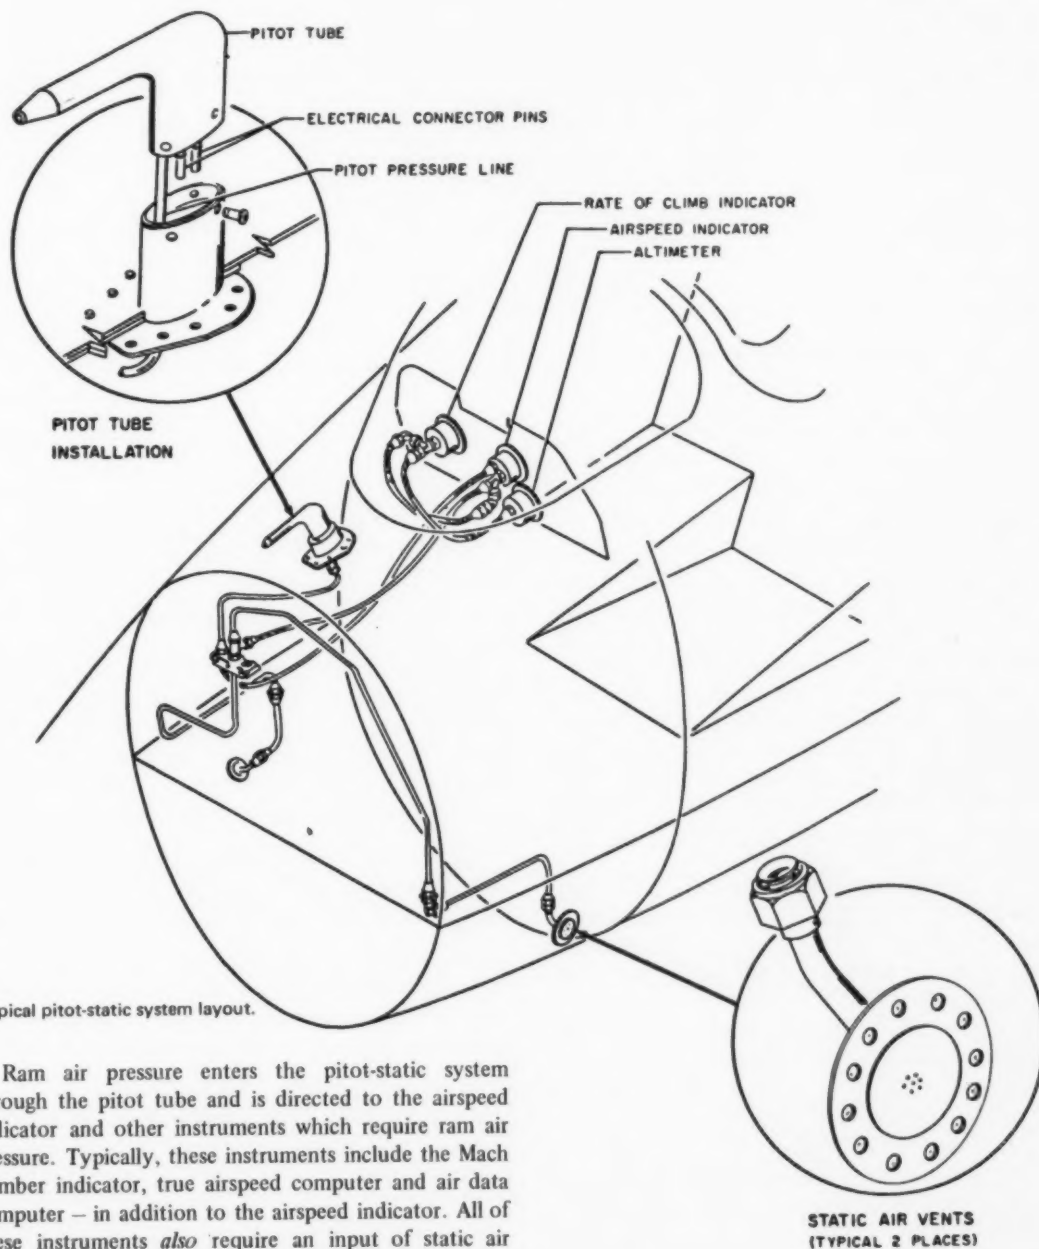
Typical pitot-static system layout.
